MARITIME HERITAGE MINNESOTA

Red Mill Wreck (21-AK-122) Report 2013

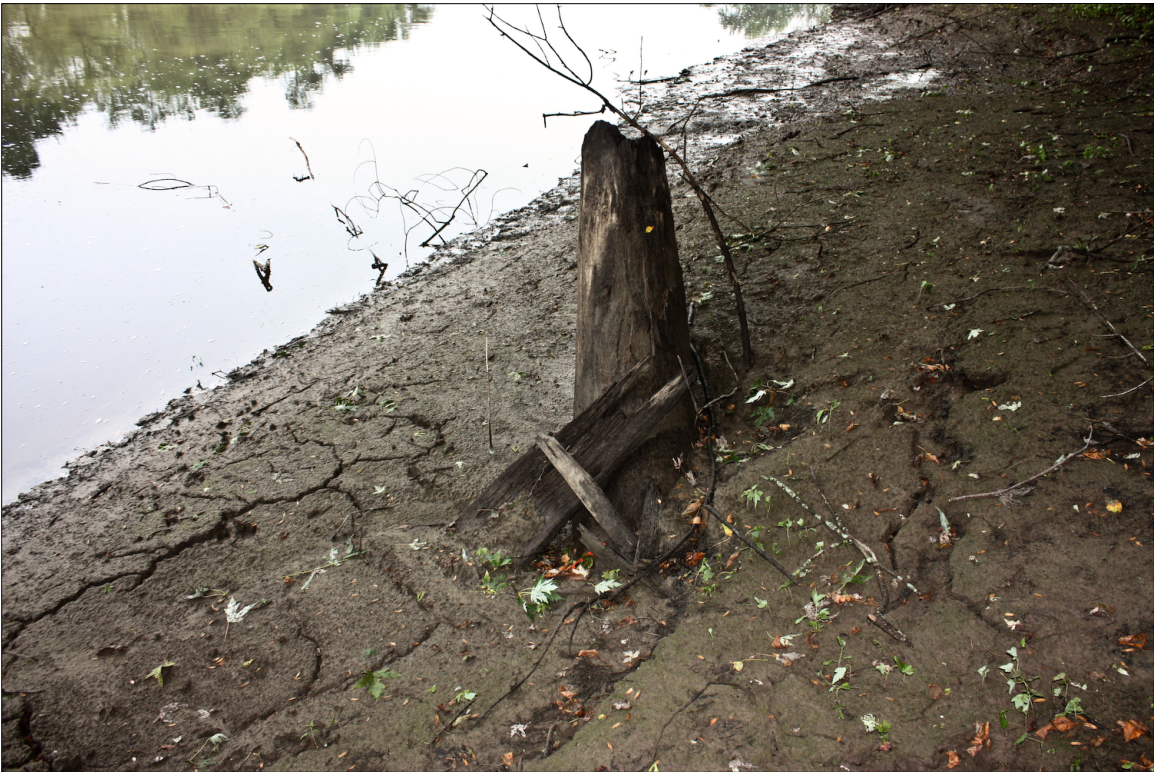
The outer hull strakes and floor seen here wedged upward by an old snag were the first indication that a submerged cultural resource might be buried in this siltbank. The snag might be the main reason most of the wreck's bottom hull has not washed away over the decades.

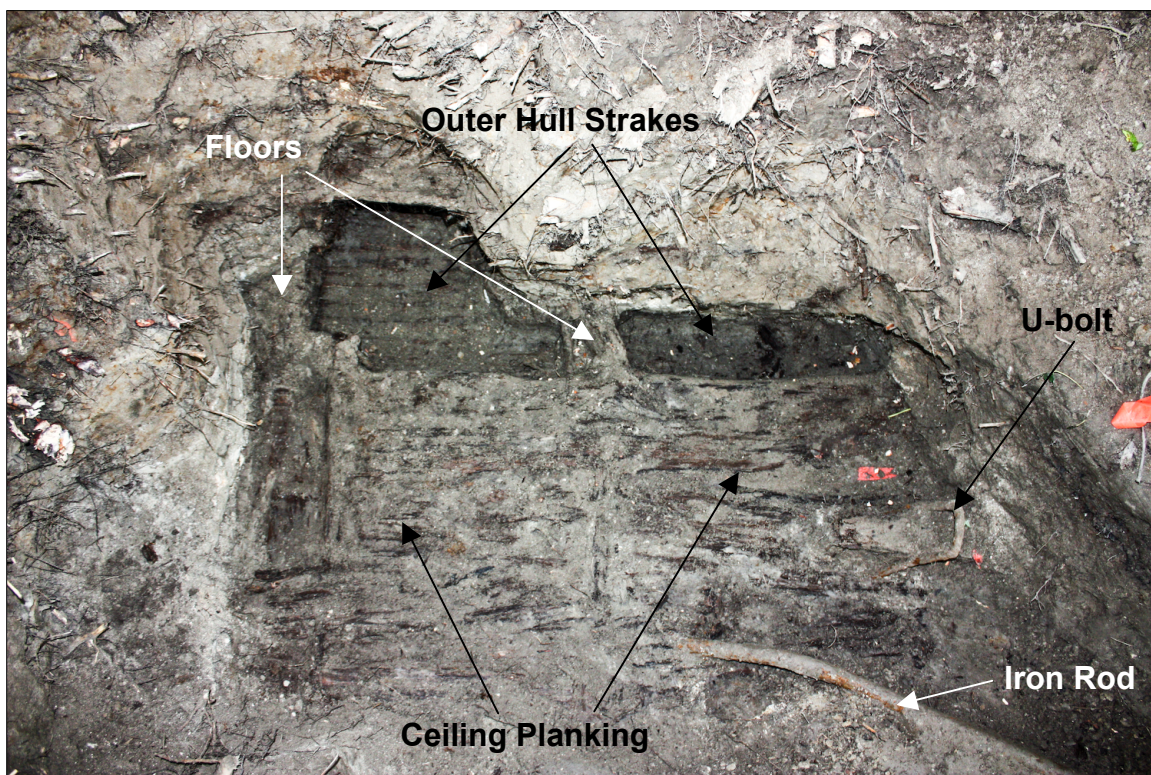
'L'-shaped Trench 2 contains intact ceiling planking, two floors visible near the top, the terminus for the iron rod, and outer hull strakes. The orange tape near the U-bolt was placed in 2012 and the U-bolt is in Trench 2.

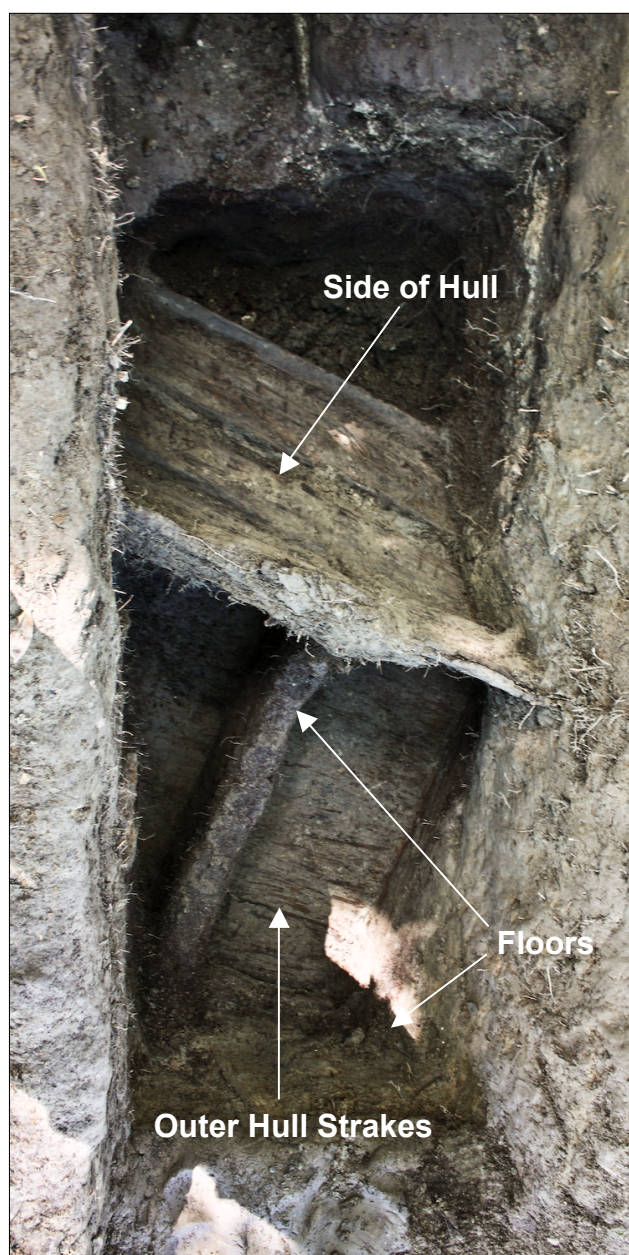
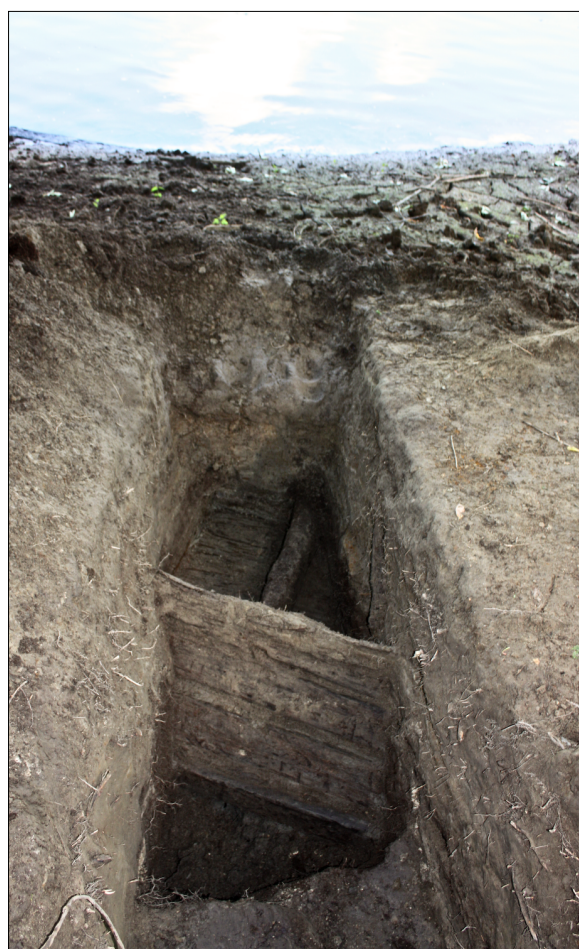
Above: Trench 3 looking toward the east. The three wide strakes in the middle of the trench are the side of the wreck collapsed toward the centerline.

Left: Trench 3 from above. The trench has 2 floors attached to intact outer hull strakes and the 'wall' running through it is the side of the hull collapsed inward.

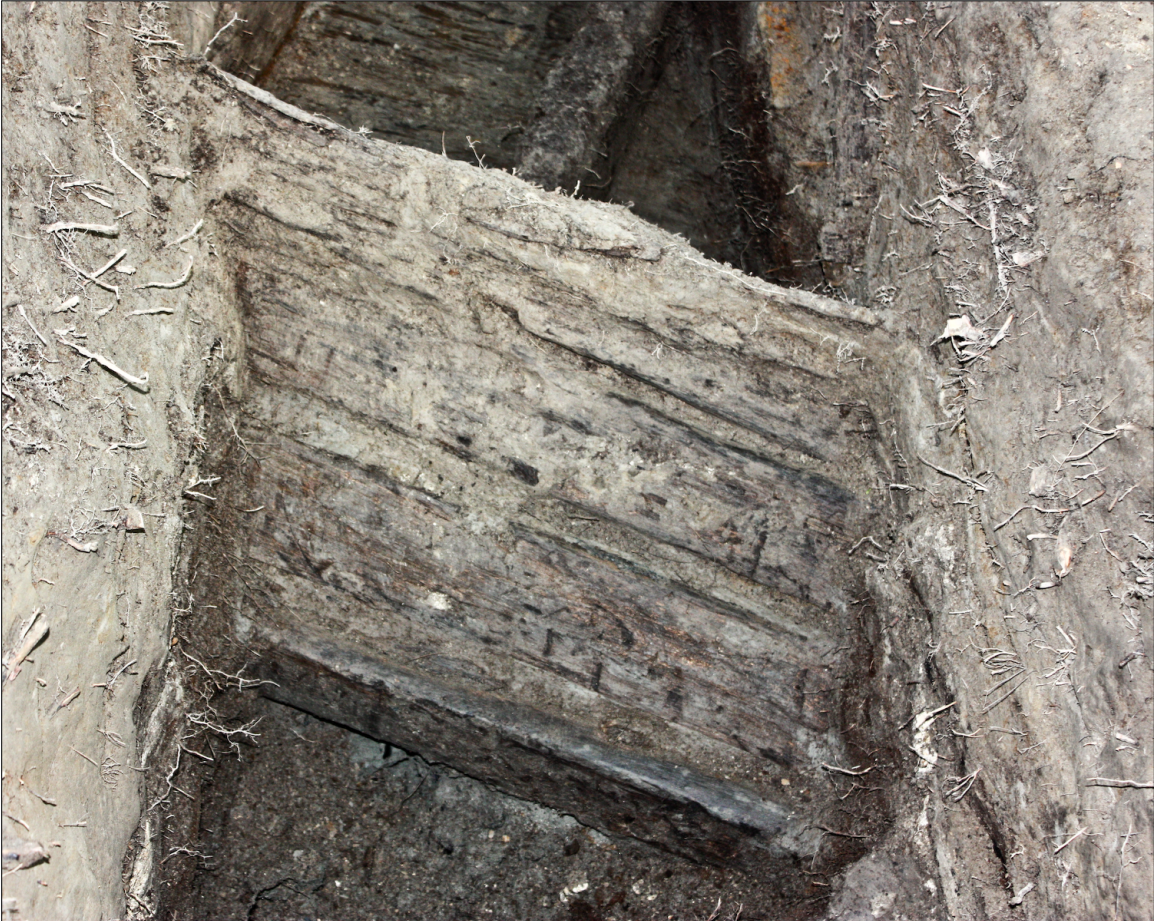
The fourth hull strake extant is not collapsed inward and butts up against the strake that creates the turn of the bilge and gives the wreck a hard chine.

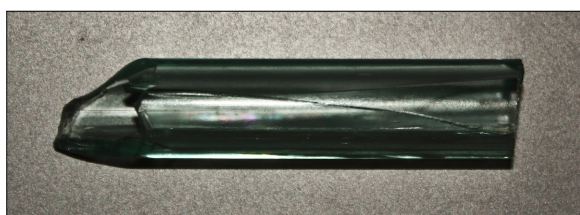
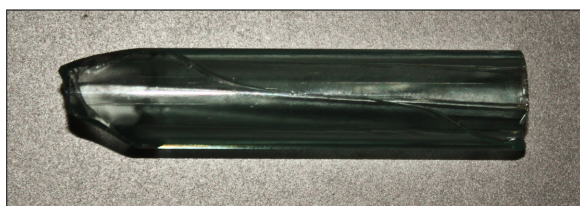
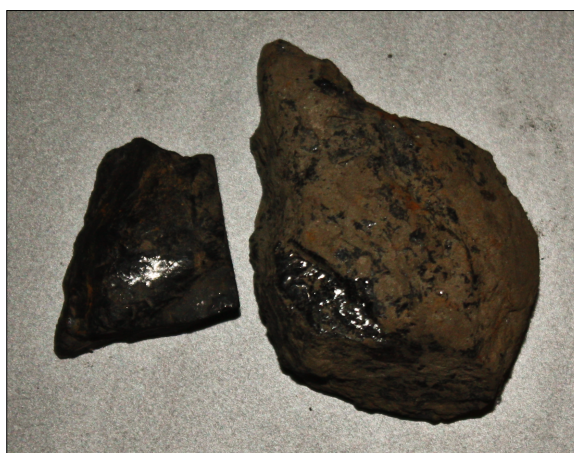
Left: The partial sight glass from Trench 3 is 2.75 inches long, .56 diameter, and .03 inches thick. There are two breaks running the length of the tube.
Right: Samples of coal located in Trench 2.

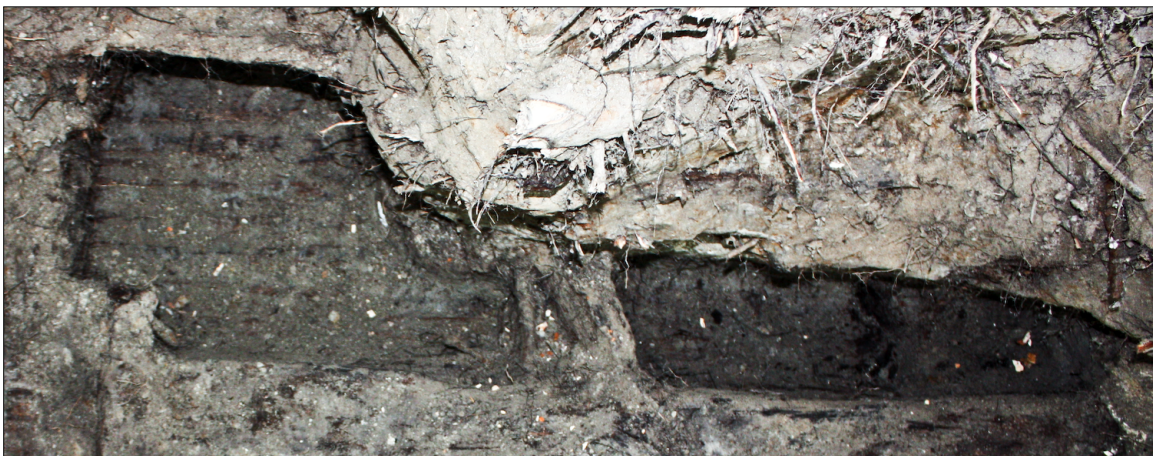
The western section of Trench 2, even after cleaning, has remnants of the gray clay-like silt layer adhering to the inner surface of the outer hull strakes.
